# Vacuum Pump Rebuild Services

Vooner FloGard Corporation has been involved in liquid ring vacuum pump applications for over 25 years. During that time we have developed the expertise to accurately diagnose and re-build Vooner, Nash, Siemens and Somarakis vacuum pumps. We can offer a Standard or a Full Clad Rebuild service as described below.

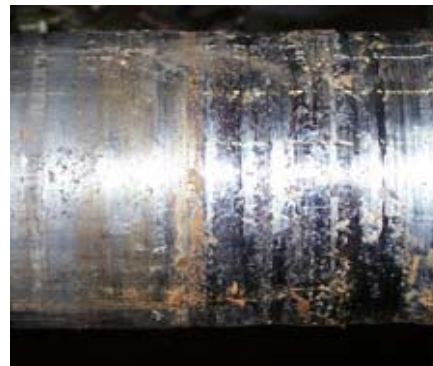
Shaft Needing Repair

- ***Vacuum pump leaks due to holes in the housing***
- ***Shaft wear in packing ring area***
- ***Bearing failure***

- **Hole in housing** allows leaks also indicates more holes will soon appear
- **Shaft wear in packing ring area** cannot control normal drip
- **Bearing failure** may cause shaft break

- **Clad the housing with Stainless Steel** to stop leakage
- **Rebuild the shaft in Packing Ring area** with metal spray coating and grinding to final dimension
- **Clad cones and match fit to rotor** by re-machining the tapers
- **Clad heads, ring housing, and rotors** to original dimensions

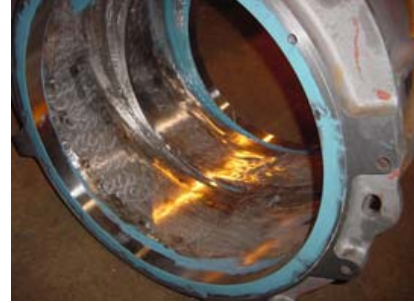
Inside of housing after cladding

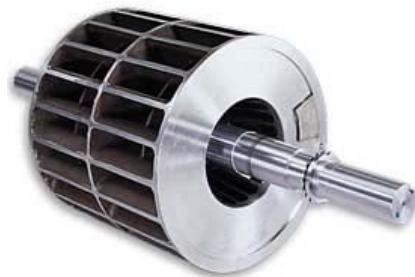
New Stainless Steel Rotor

- **Attempting to restore iron vane dimensions with nickel weld** has a failure mode of the nickel weld chipping off
- **Performance can be restored to 90% of original airflow** by cutting a new larger dimension taper in rotor
- **Remanufacture of the pump** may include replacement with a new stainless steel rotor.
